E16	Product/component/test step
	Vehicle/engine

Trouble-shooting program

1. Test specifications

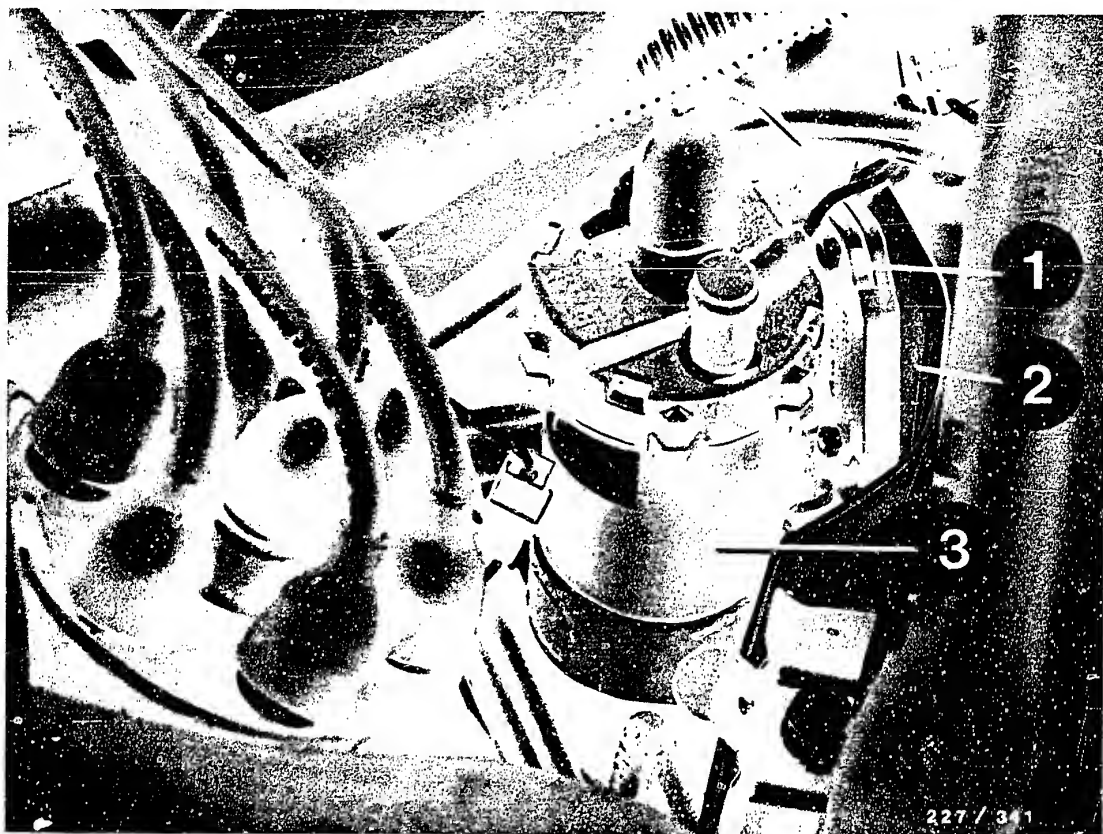
- 1 = TI trigger box
- 2 = Heat sink
- 3 = Ignition coil

The trigger box and ignition coil are mounted on a common heat sink. See picture.

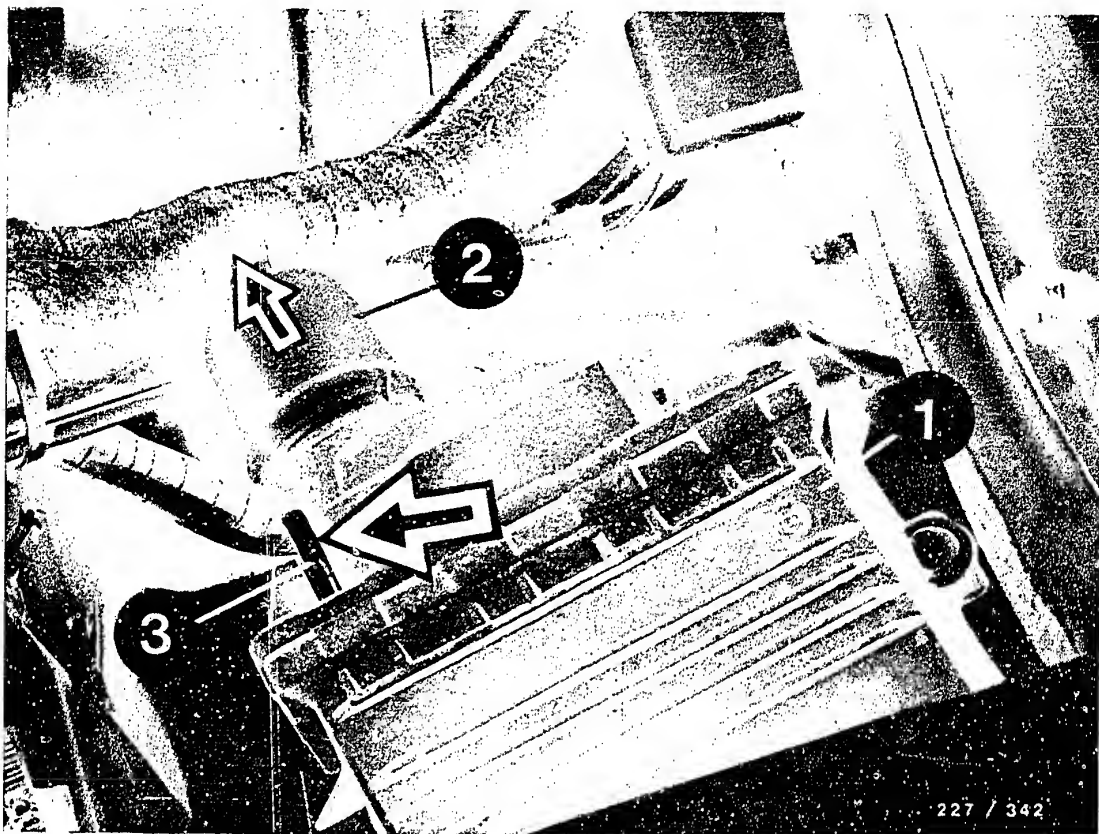
- 1 = Timing advance unit
- 2 = Timing advance unit plug
- 3 = Detent

The timing advance unit is on the wheelbox on the left-hand side in the forward direction of travel. See picture.

Press detent for timing advance unit plug in direction of arrow, and hinge plug in direction of arrow.

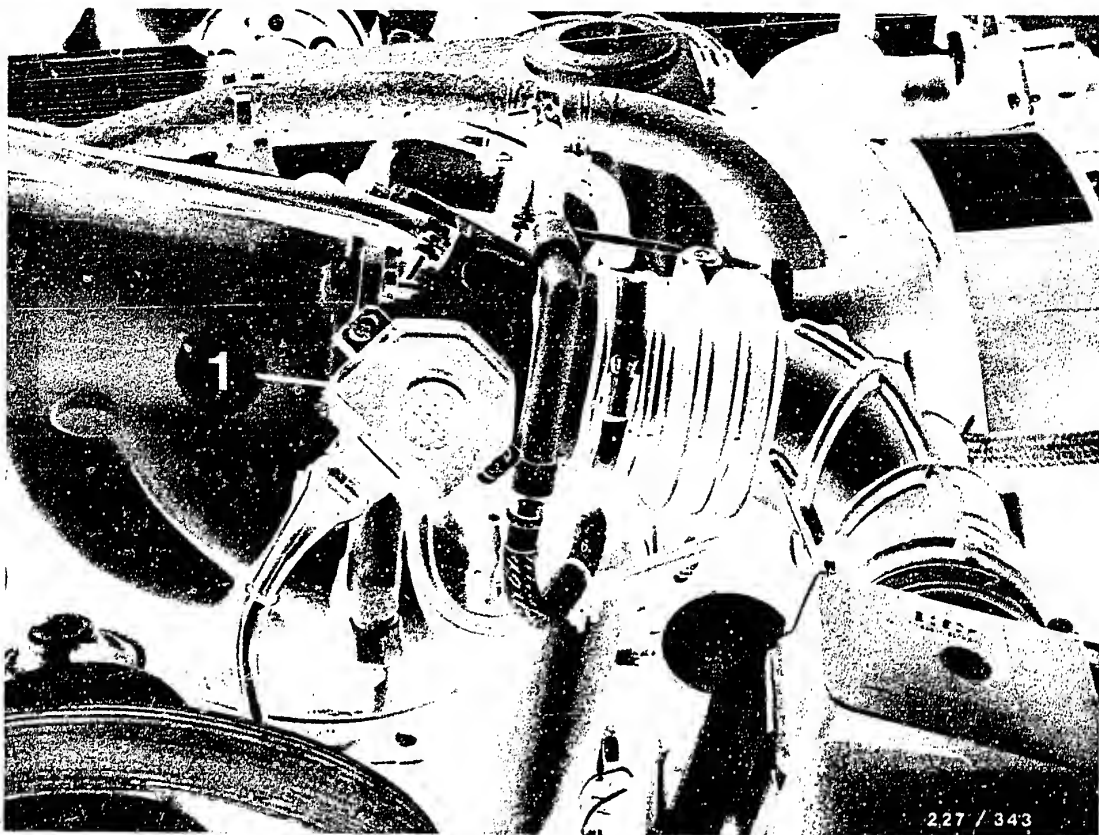
1 = Throttle-valve switch

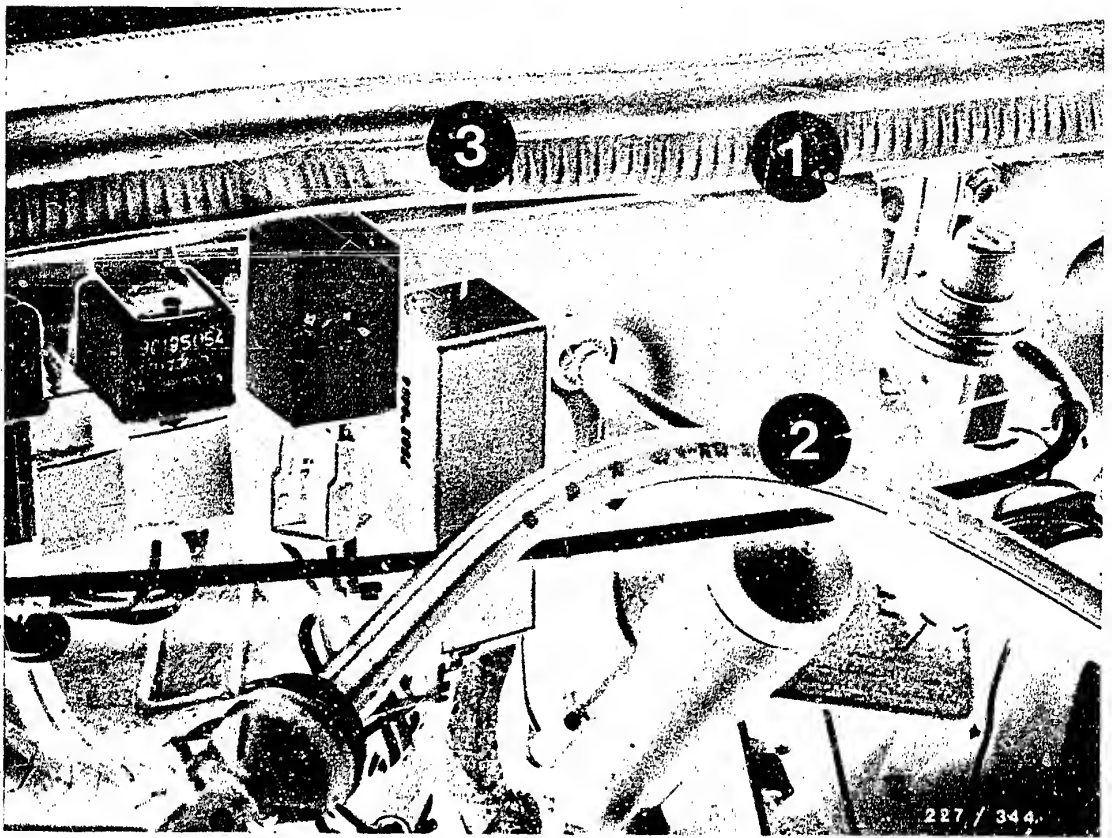
- 1 = Part-load switch
- 2 = Vacuum connection
- 3 = Control relay for L-Jetronic (version LE 2)

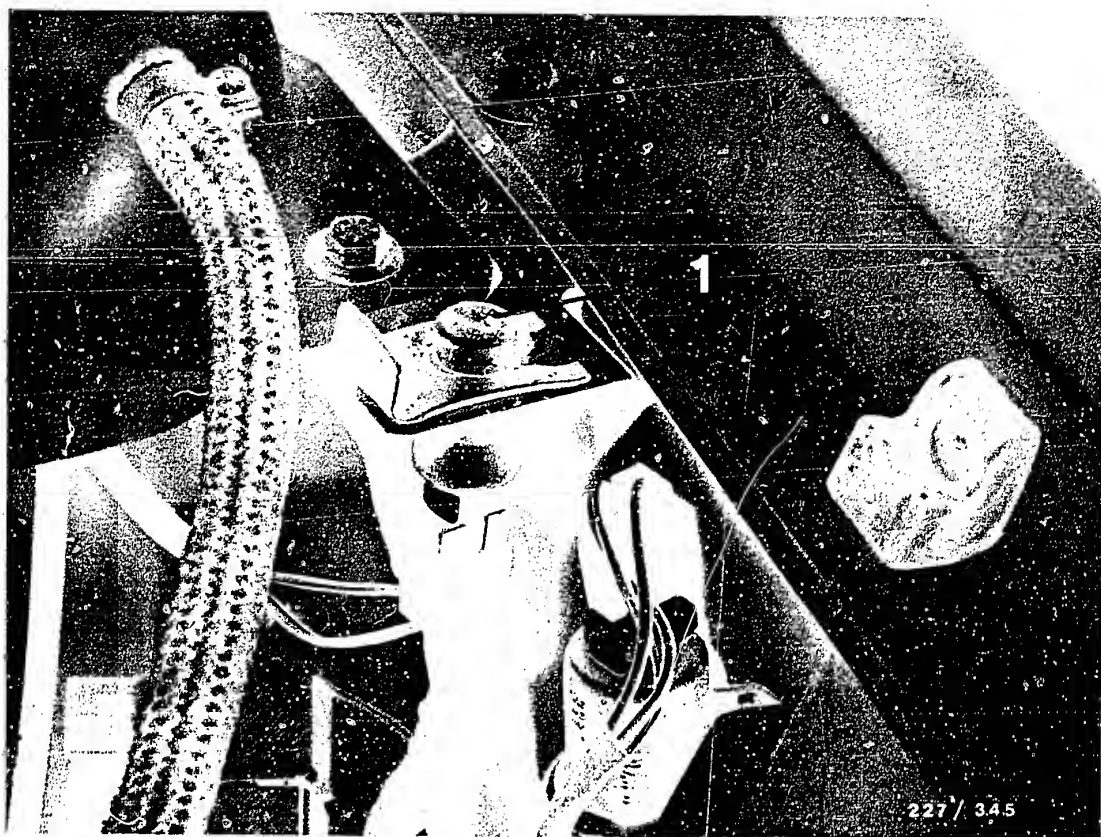
1 = Thermo-switch (air)

The thermo-switch is next to the coolant expansion tank. See picture.

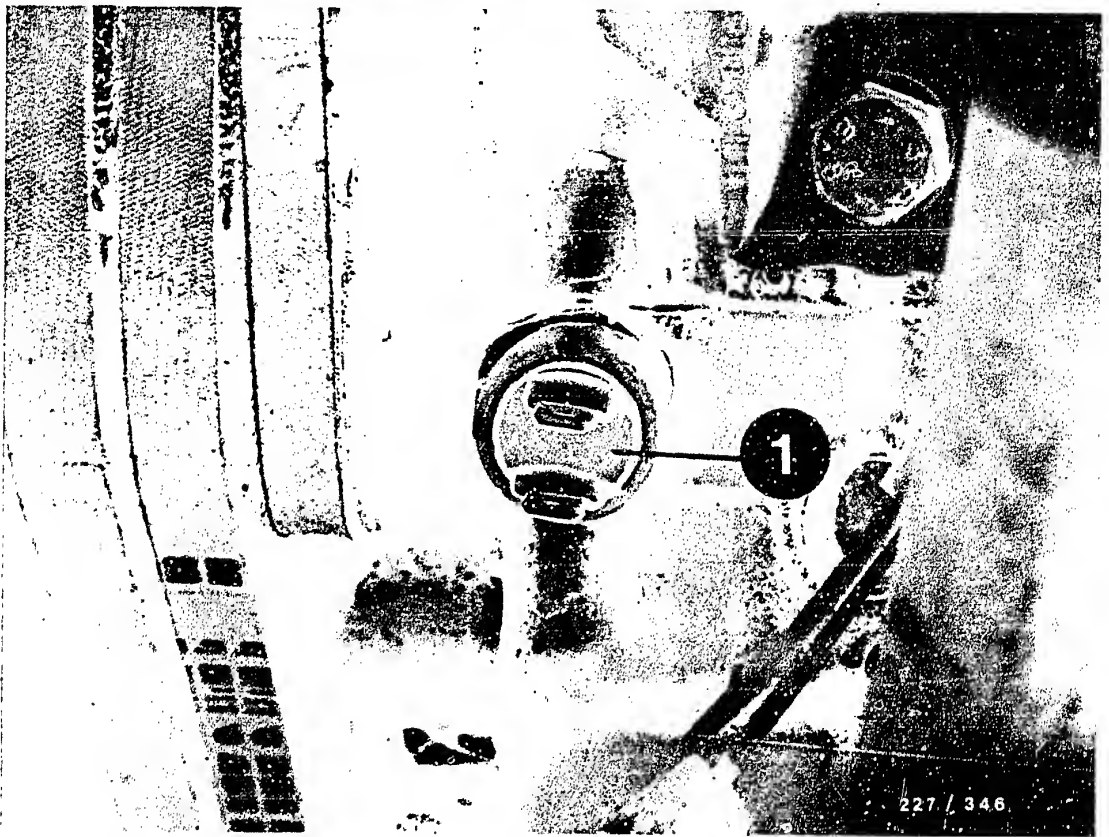
1 = Oil-temperature switch

The oil-temperature switch is at the front on the engine on the left-hand side in the forward direction of travel. (Near crankshaft pulley).

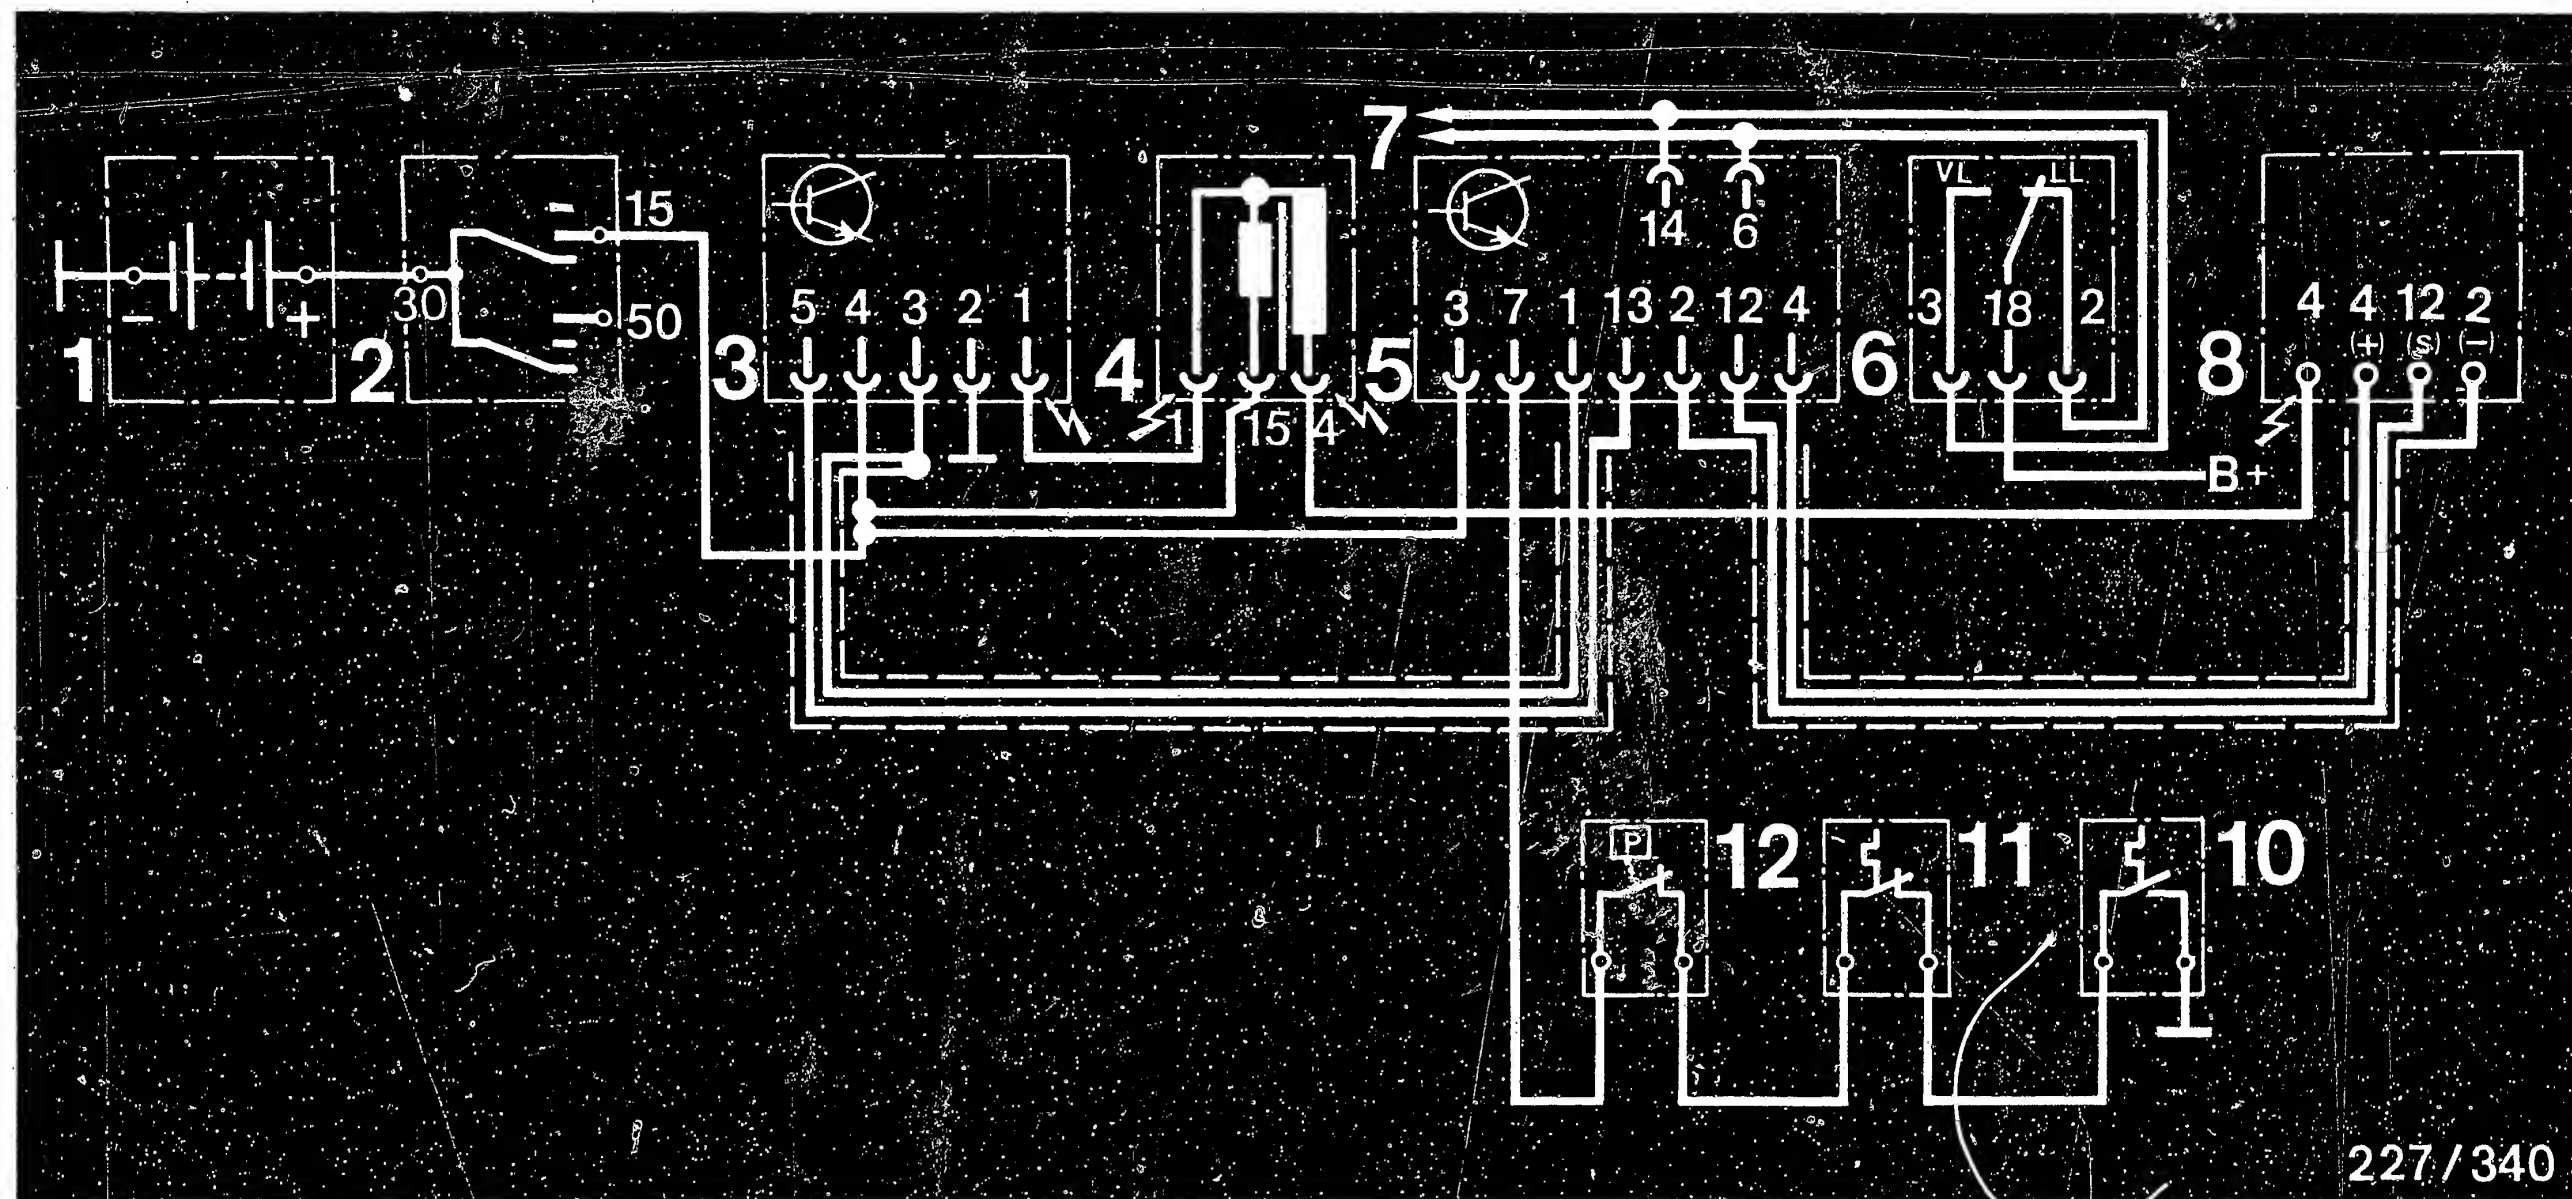
⚡ = Dangerous voltages (400 V - 25 kV)

- 1 = Battery
- 2 = Ignition and starting switch
- 3 = Trigger box
- 4 = Ignition coil
- 5 = Timing advance unit
- 6 = Throttle-valve switch

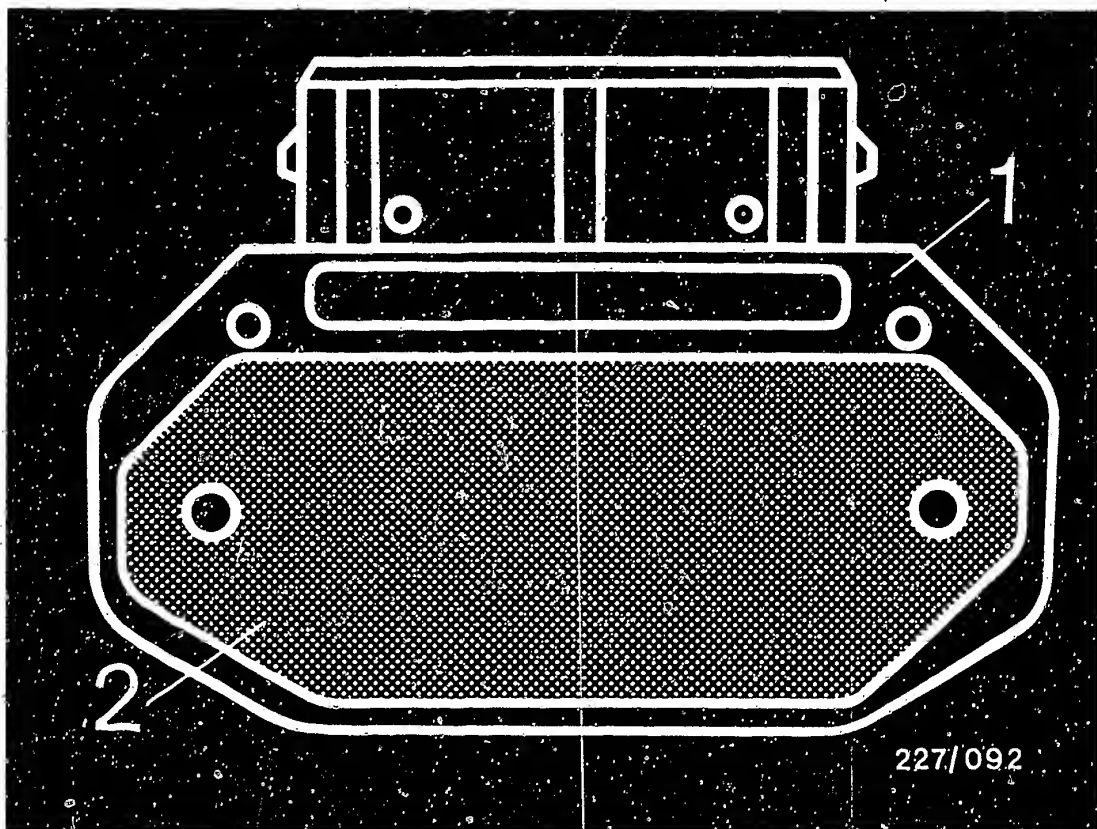
1 = Trigger box

2 = Base plate

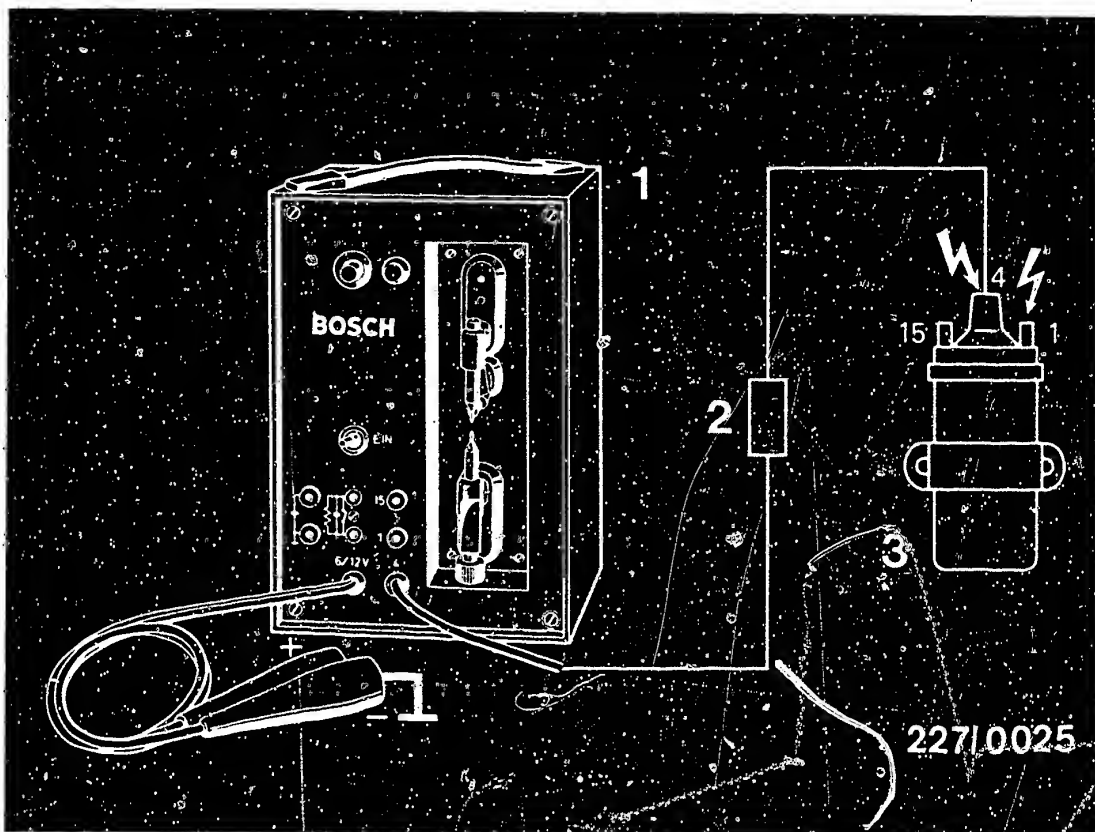
- 1 = Spark gap
- 2 = 5 k Ω sleeve-type suppressor
- 3 = Ignition coil

- In order to prevent the trigger box from being irreparably damaged, when using a spark gap, an interference-suppression resistor of at least 2 k Ω must be connected between the spark gap and ignition coil terminal 4, e. g. sleeve-type suppressor (5 k Ω) 0 356 500 001.

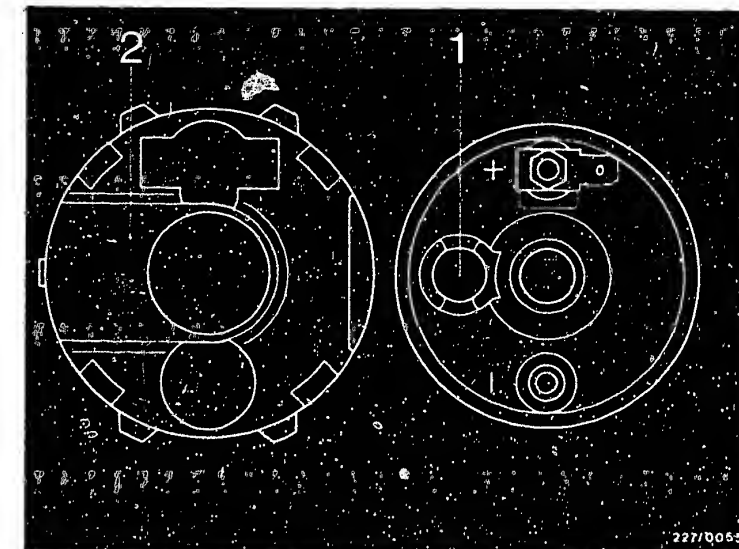
B11

1 = Plug
2 = Protective cap

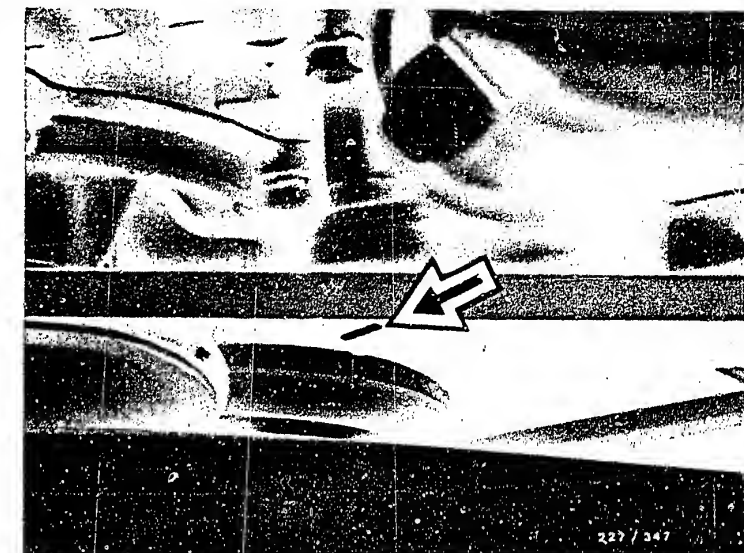
Ignition timing mark (10° BTDC)

Loosen ignition distributor mounting and turn ignition distributor until marks align (10° BTDC).

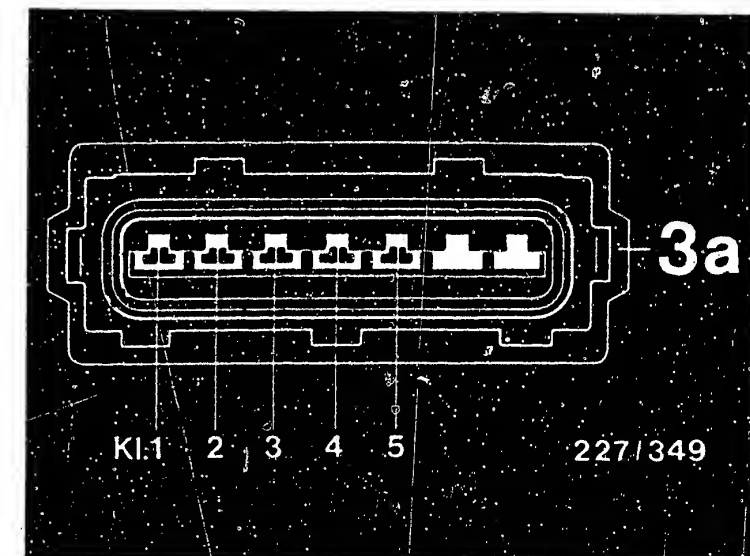
3a = Trigger-box plug

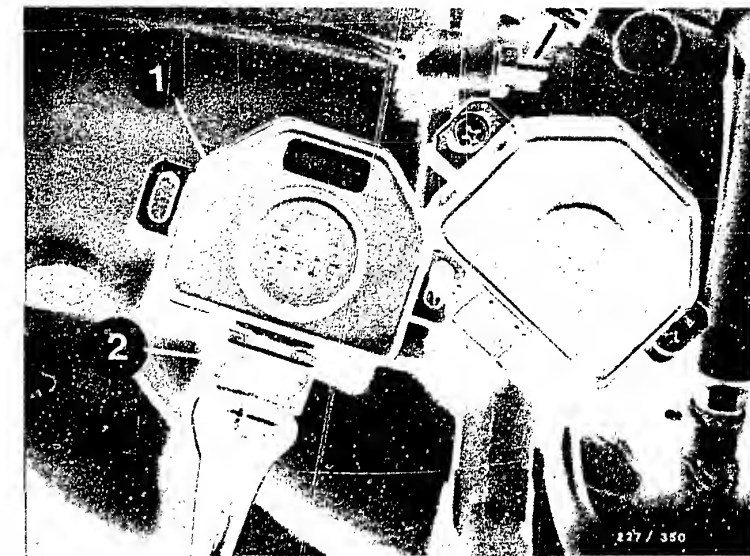
- 1 = Short-circuiting device KDZS 0003
- 2 = Throttle-valve switch plug

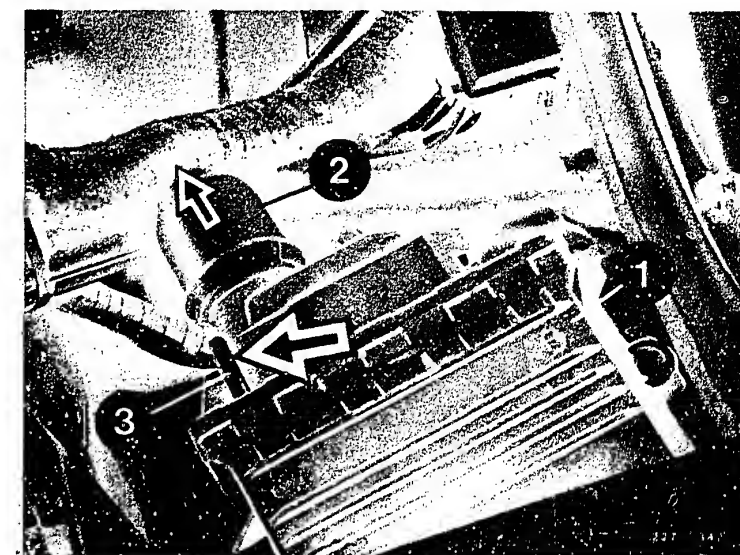
- 1 = Timing advance unit
- 2 = Timing advance unit plug
- 3 = Detent

Timing advance unit plug

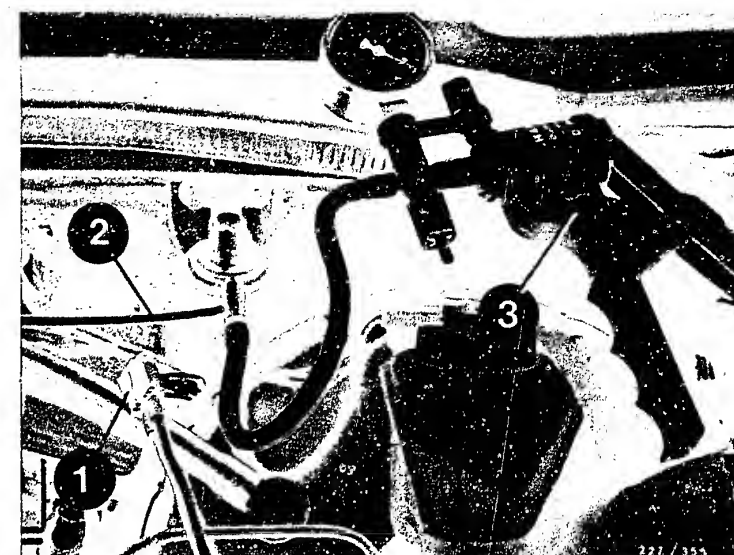
1 = Part-load switch plug

2 = Vacuum hose

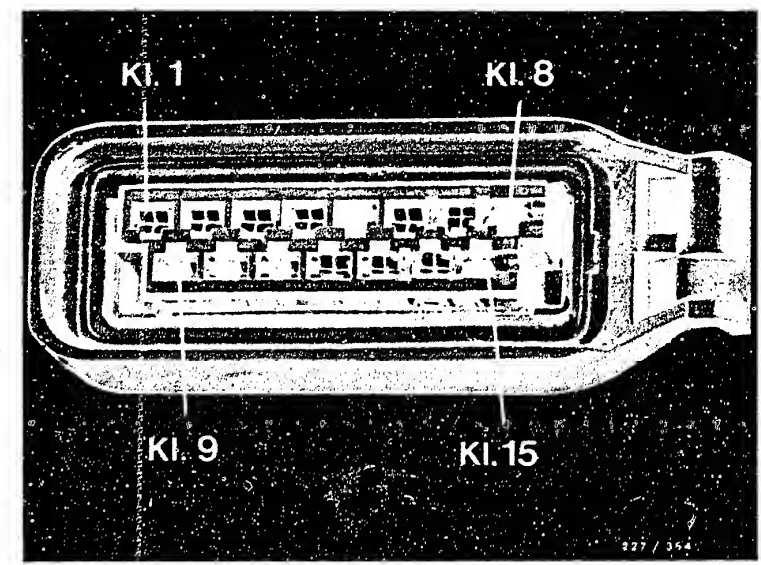
Timing advance unit plug

1 = Throttle-valve switch

If resistance ∞ (infinity), first of all adjust throttle-valve switch. To do this, slightly loosen fastening screws. Turn throttle-valve switch until idle contact (microswitch) can be heard to click (reading 0 Ω). If resistance is still ∞ , then replace throttle-valve switch.

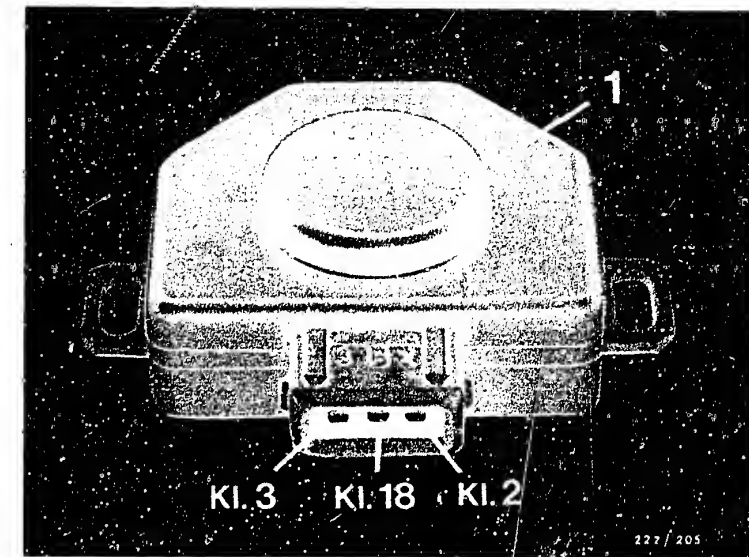
1 = Throttle-valve switch

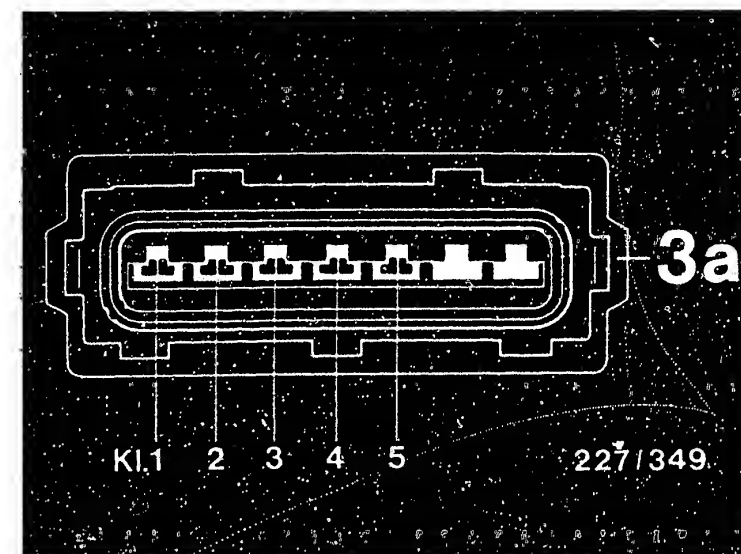
3a = Trigger-box plug

Check for open circuit in cable from
ignition and starting switch to
ignition coil term. 15, in the pri-
mary winding of the ignition coil,
in the cable from ignition coil term.
1 to trigger-box plug term. 1 and in
the ground cable term. 2.
Eliminate open circuit.

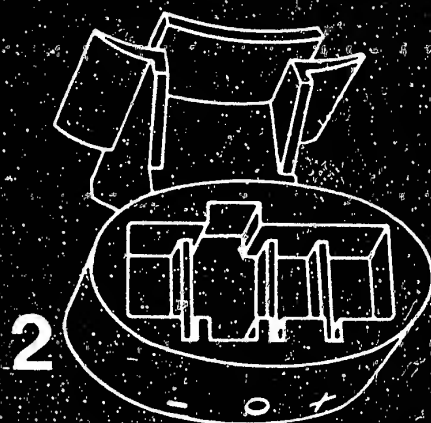
1 = Ignition-distributor connector

Remove the ignition-distributor connector (see picture) and check contacts for oxidation and correct latching (remedy defects).

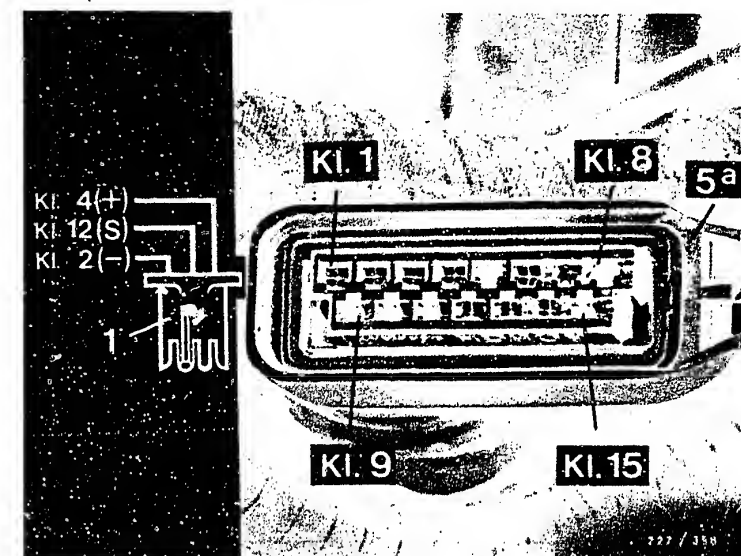
1 = Ignition-distributor connector
5a = Ignition timing unit plug

3a = Trigger-box plug

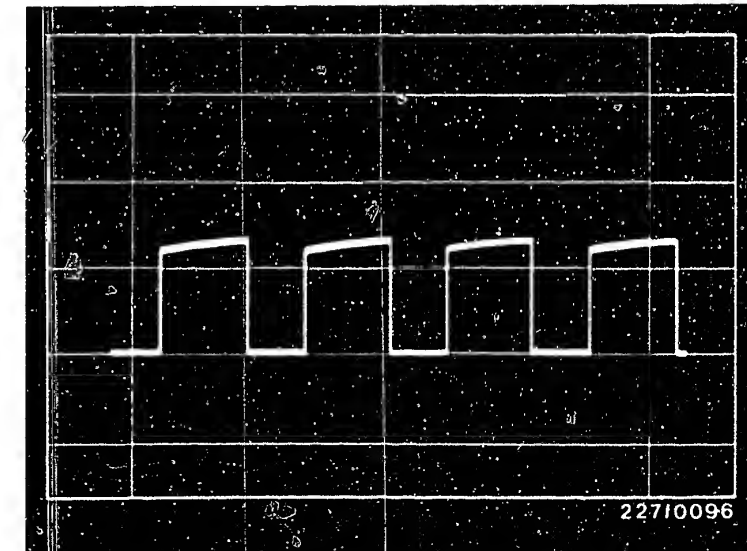
D6

1 = Ignition-distributor connector

Rectangular pulse

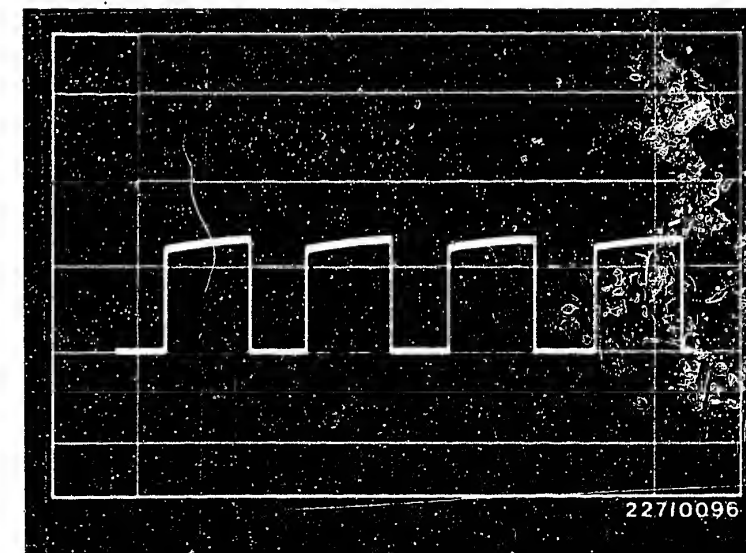
D8

3a = Trigger-box plug

Rectangular pulse

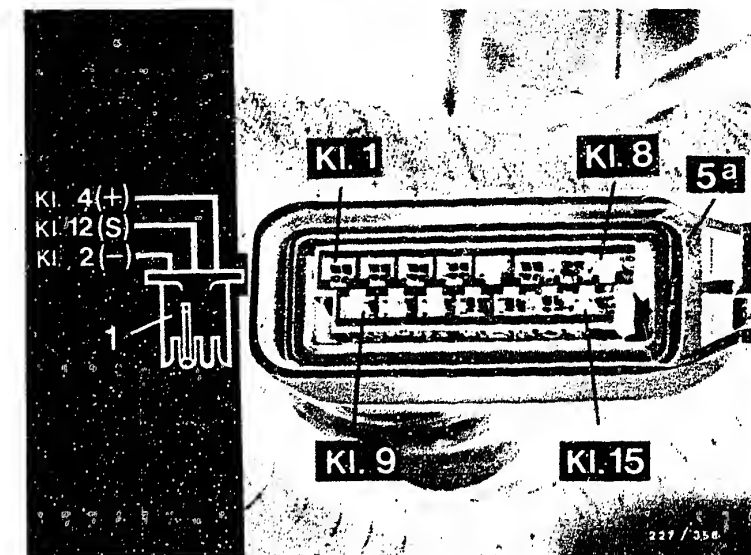
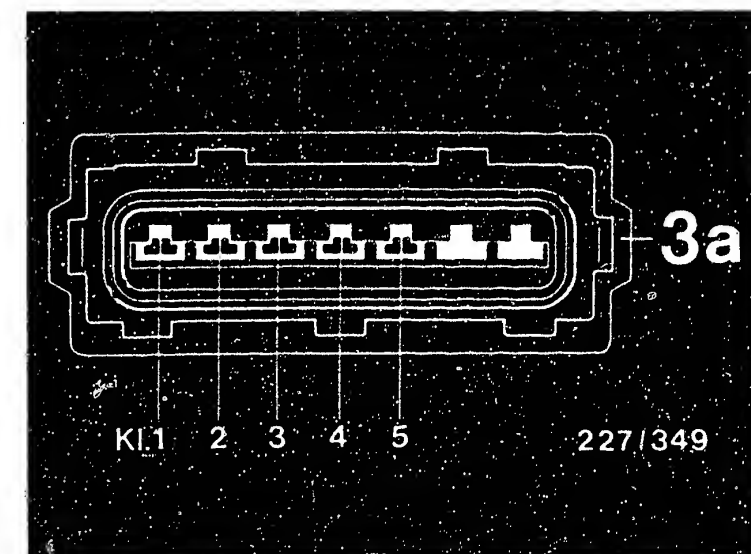
D 10

1 = Ignition-distributor connector
5a= Ignition timing unit plug

3a= Trigger-box plug

If there was no open circuit, replace ignition timing unit.

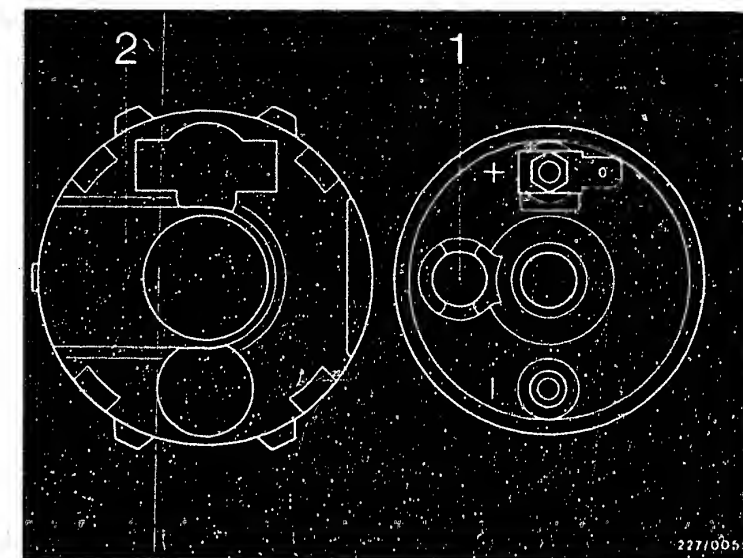
1. If plug is not in position and/or sealing compound has escaped, replace trigger-box, ignition timing unit and ignition coil.

2. If resistance values are not O.K., replace ignition coil.

1 = Plug
2 = Protective cap

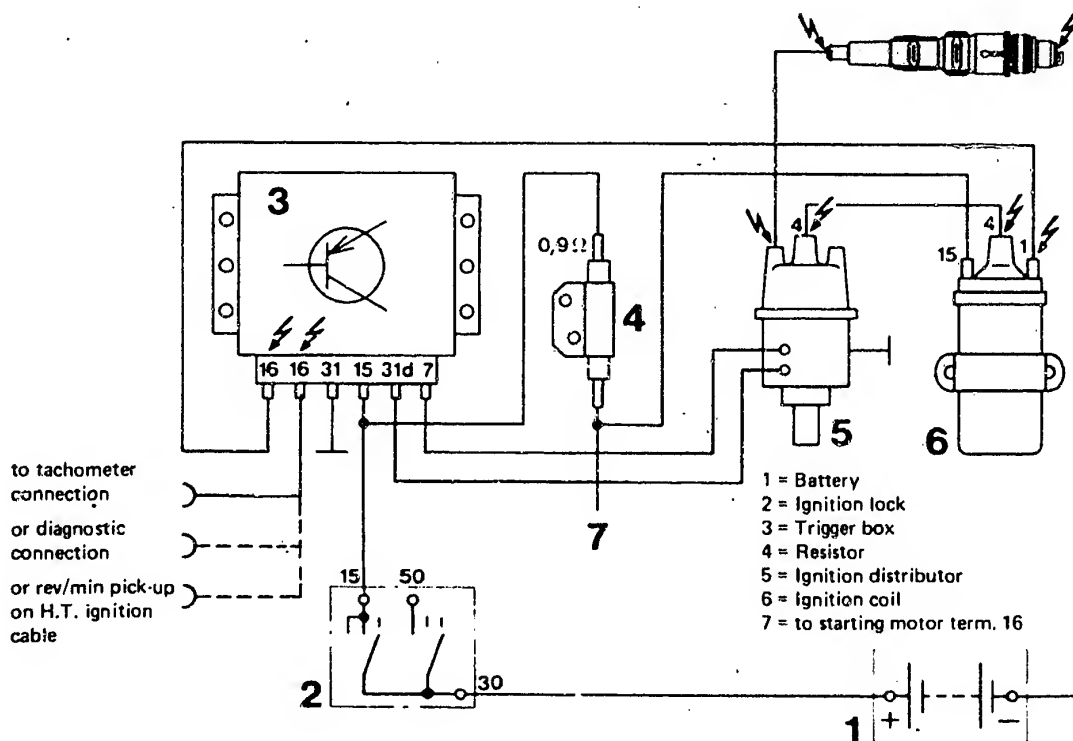
Terminal diagram

Below is a typical terminal diagram of a semi-conductor ignition system, the danger points are marked with red high-voltage arrows. We would point out that all semi-conductor ignition systems, even the older ones, are to be regarded as dangerous in the sense as defined by this bulletin.

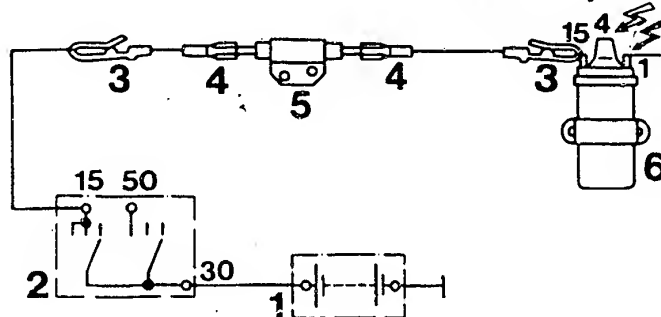
Part No. 6 210 150 150

Commercially available

1 = Battery

2 = Ignition switch

Connect a ballast resistor of 0.9 or 1.0 Ohm (see Fig.) in series in the line to term. 15 of the ignition coil (take care not to cause a short circuit). After the rotational-speed measurement, the ballast resistor must be removed (otherwise starting difficulties and misfiring). Connect tester as per operating instructions.
